*Client: Steve Davis*  
*Site Address: 6200 E COUNTY RD 56 Fort Collins*  
*Inspection Date: 01/13/2019*  
*Report # 1151*

## PROPERTY CONDITION REPORT

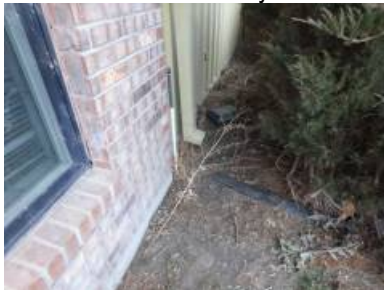
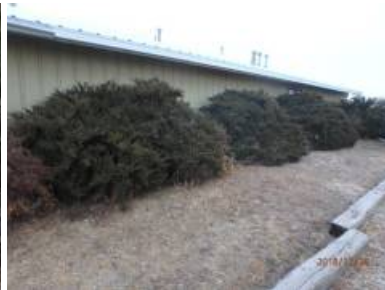
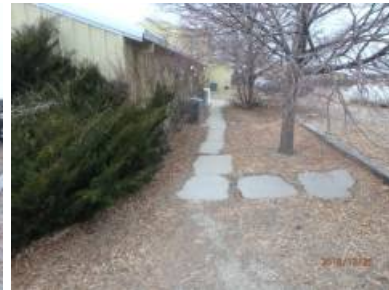
Trees are planted very close to the foundation, this condition can lead to displacement of the foundation. All bushes and trees should be removed away from all the structure.

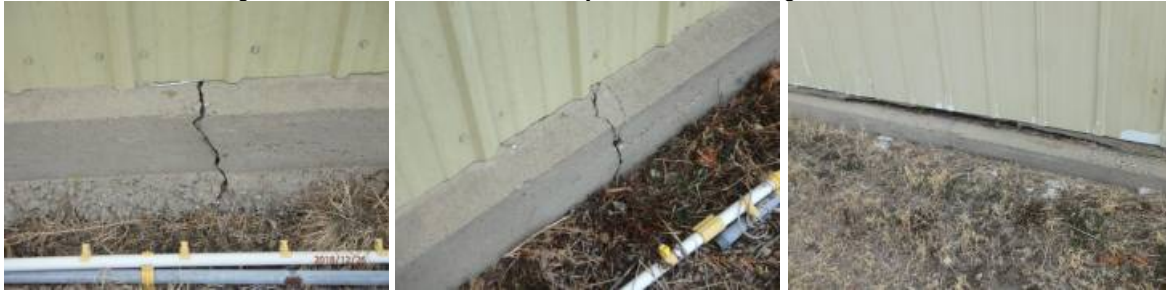
Cracks, there is damage to the bibs on the outside entry to several buildings.

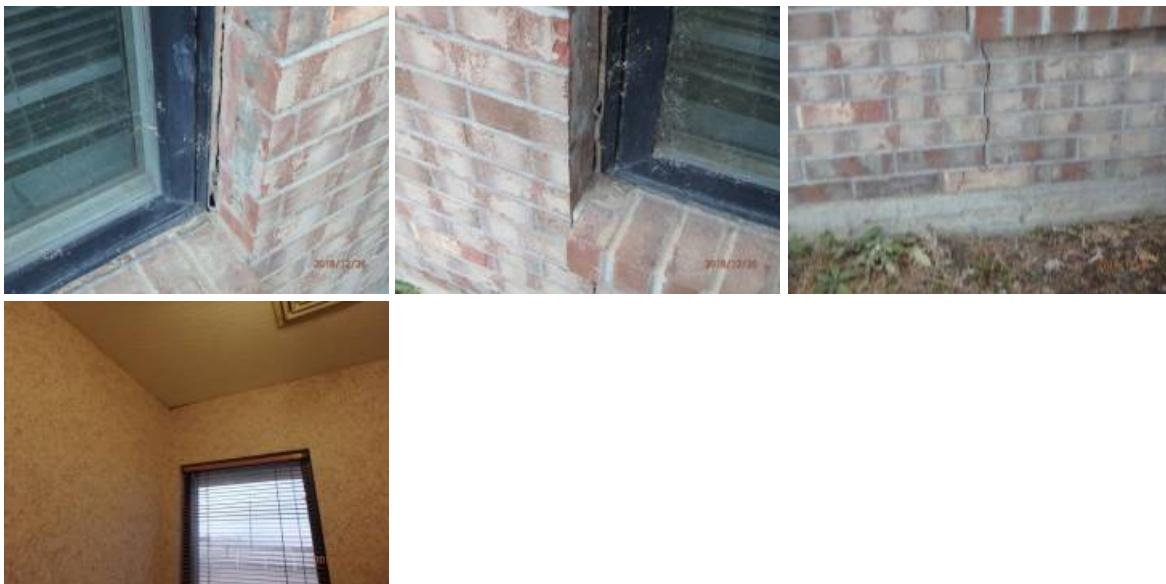
Framing of the load bearing walls appears to be constructed of dimensional wood (conventional stud type construction). However, since most of these cavities are not available for inspection, we are unable to verify that all walls are of this type. There is evidence of settlement where poor discharge has occurred in the front of the main building. The broken footing has created visual settlement in the brick work and cracks and settlement in the conference room.

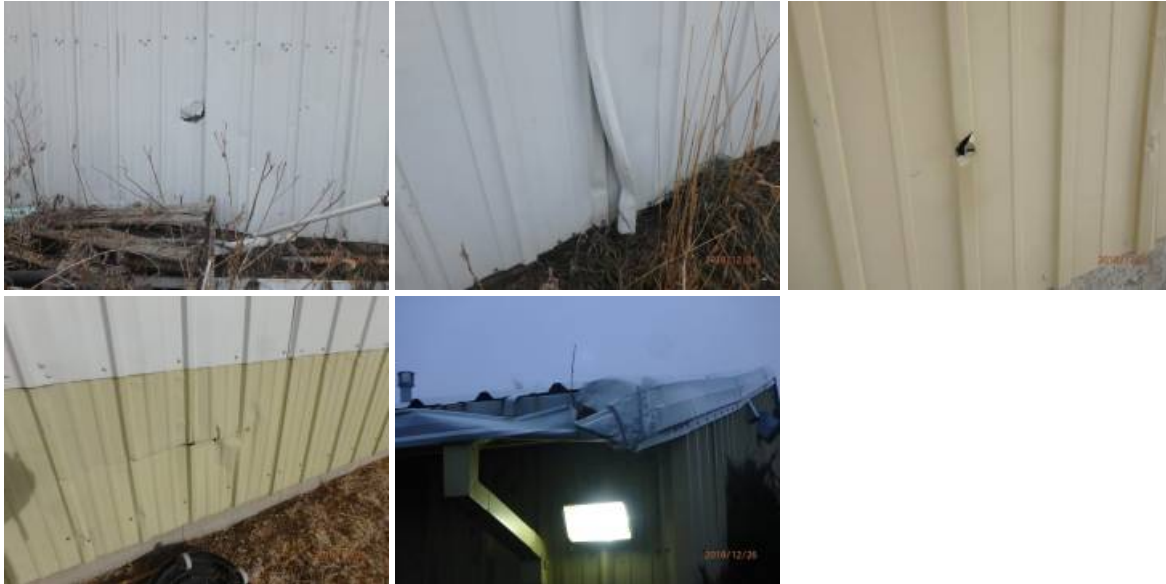
Sidewall system(s) consists of metal. Damage/deterioration noted at the following areas: most of the building has damage that will require replacement.

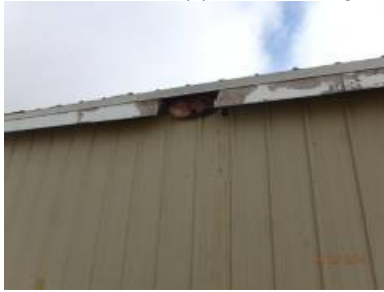
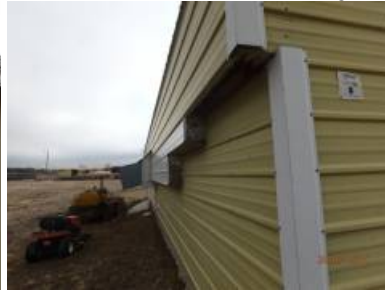
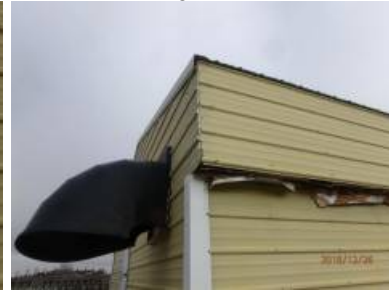
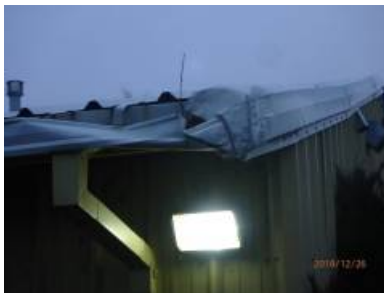
The fascia board(s) is/are damaged/deteriorated at the [Main building, Spruce, Aspen, Mugho].

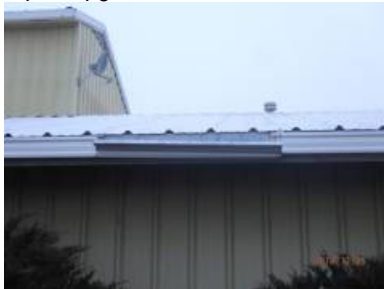
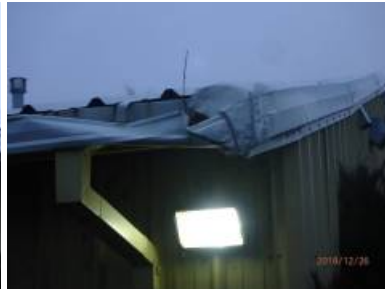
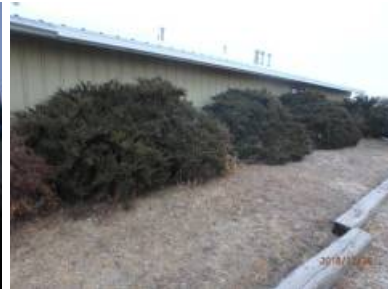
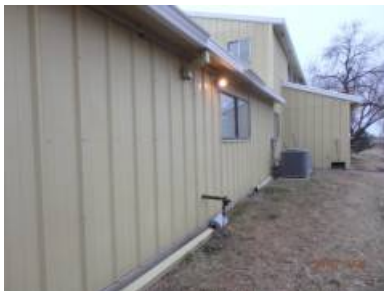
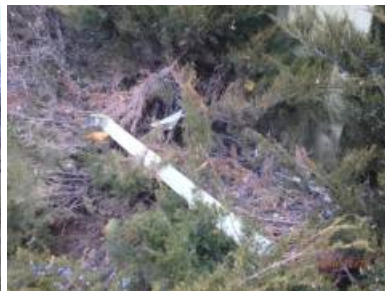
Consider installing gutters and downspouts to help with site drainage, There is an older gutter system installed in need of repair/upgrade.

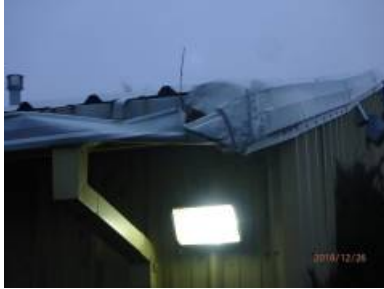
Damage/Defects viewed at S/E corner.

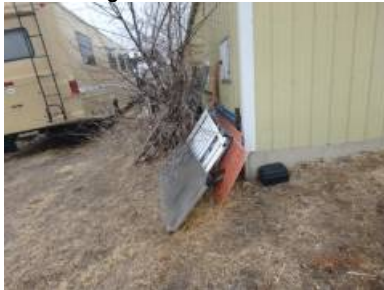
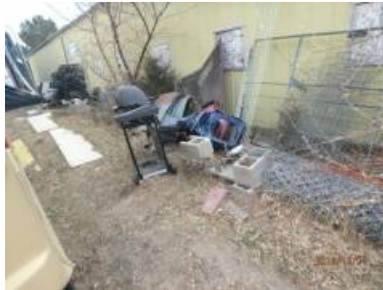
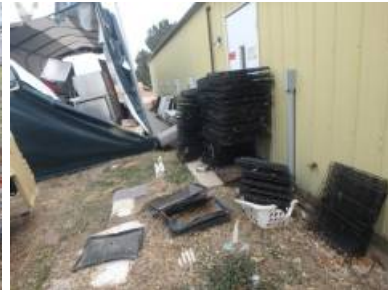
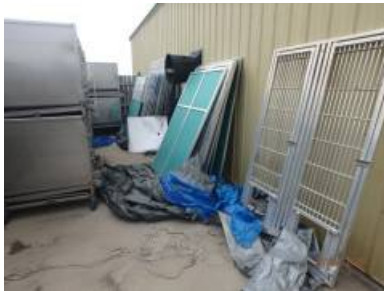
All building debris needs to be removed.

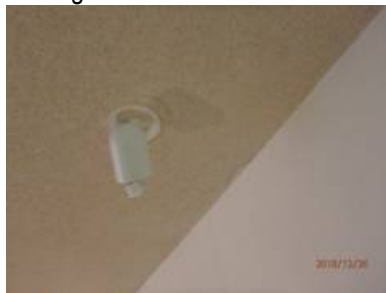
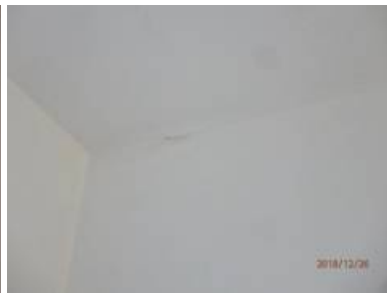
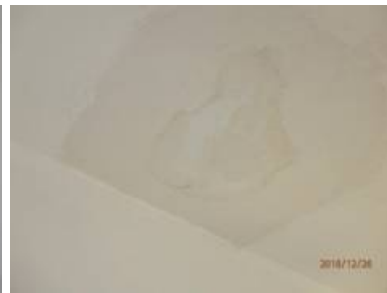
There is water staining on the underside of the roof decking or rafters. The stains are not currently wet nor do they have an elevated moisture content. there has been several leaks both in the main building as well as the other structures. No recent leaks were noted ,all previous leak damage has not been repaired ,stained ceiling ,holes in walls damaged and stained ceiling and flooring areas.

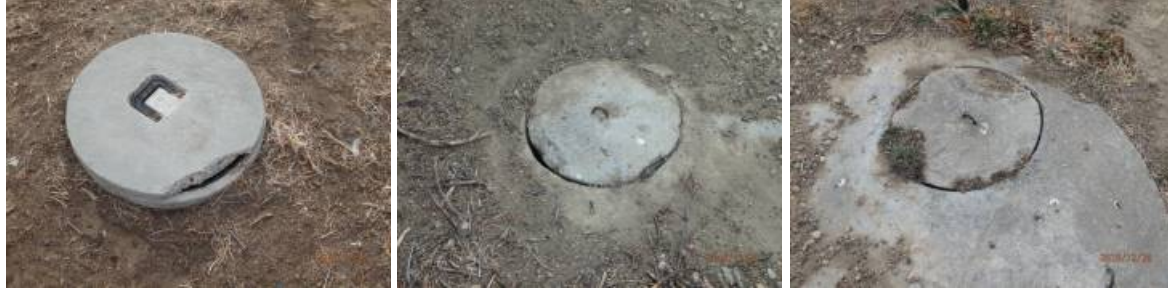
There are several broken caps to the septic tanks.

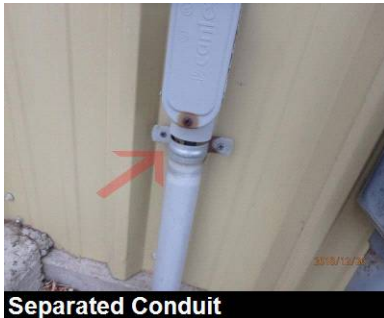
Separated Conduit

The conduit for the electrical service is damaged and may need to be repaired. [main building]

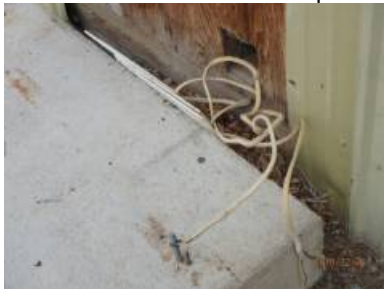
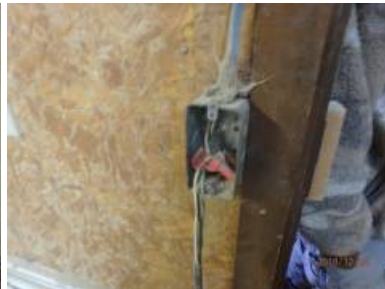
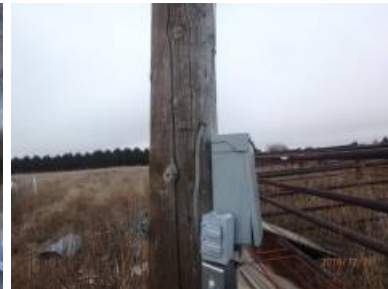
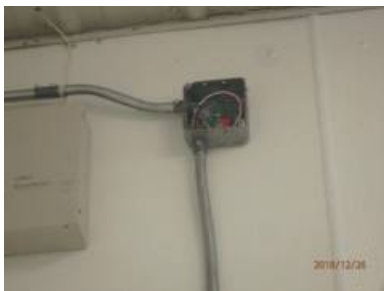
All wiring should be concealed within the structure or properly housed in protective enclosures. Have a qualified electrician correct this condition. Electrical equipment was observed which appears to be abandoned or no longer in use. This equipment should be disconnected and removed if possible.

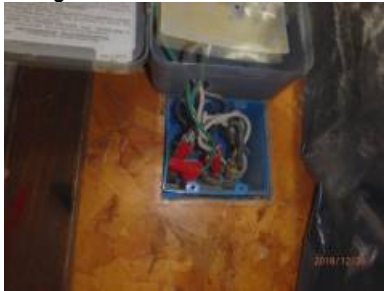
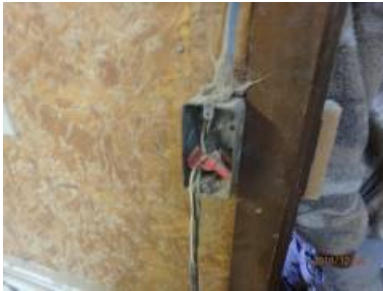
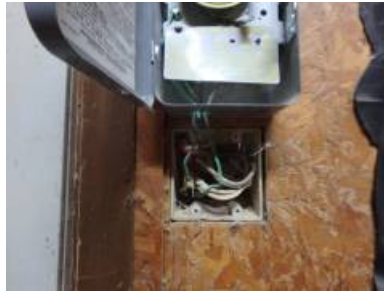
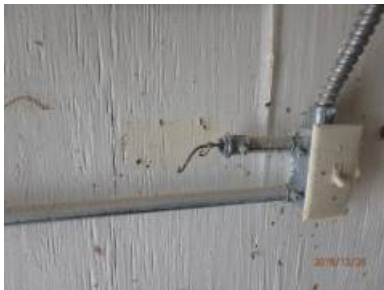
Exposed Romex wiring connections were observed. All wire splices should be enclosed in a junction box and covered with a cover plate. There are unsafe wiring conditions through out the main building wiring ,unsafe wiring,extention cords being used as wiring.

Due to the type or number of electrical hazards which were found, we believe that someone other than an electrician has been working on this system. Therefore, we recommend that a properly licensed and qualified electrician examine the entire electrical system and make recommendations for correction.

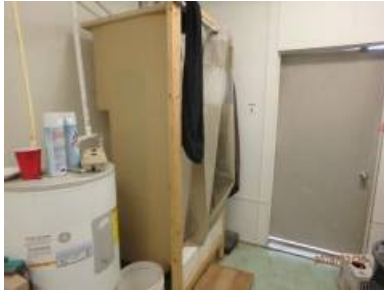
A shower has been installed next to a electrical panel . This is both unsafe and not legal. Clearances around an electrical panel are to be 18 inches on either side and 30 inches in front with no water source within 6 ft.

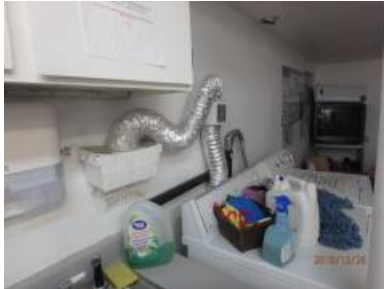
The dryer is improperly vented into the attic space. This creates lint buildup and is considered a potential fire hazard = Reroute the vent to the exterior of the home.

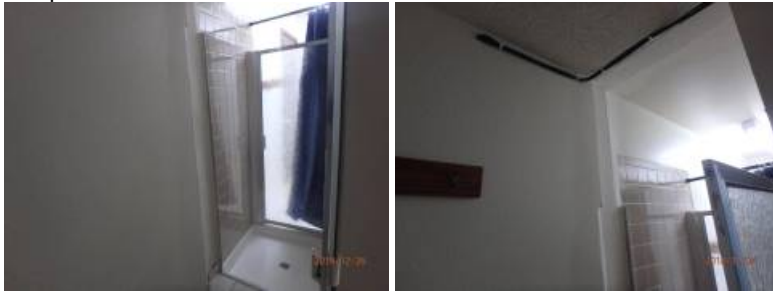
Wall Type, Drywall, Wall Condition - The walls are wavy which indicates amateur workmanship. there are also areas that are not complete.

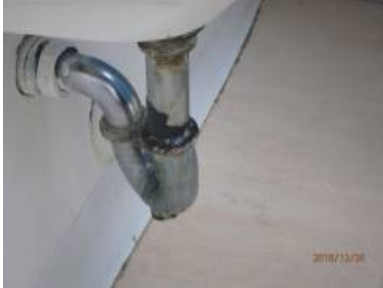
The following conditions were noted at the drain: poorly installed.

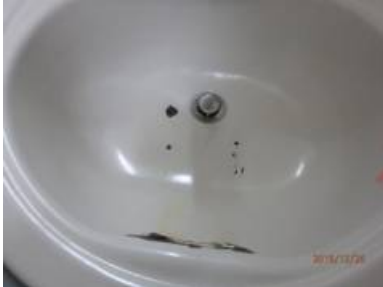
Chipped. Fixture is chipped and should be repaired. If left unattended, possible rust, corrosion or additional peeling will occur.

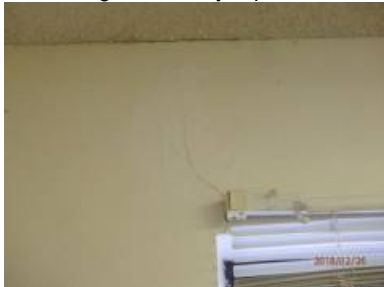
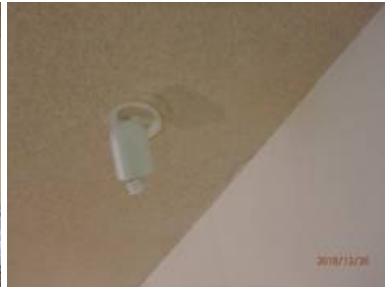
Ceiling Type, Drywall, There is a condition in the ceiling that needs to have attention. There is evidence of an unrepaired stain on the ceiling caused by a prior moisture leak.

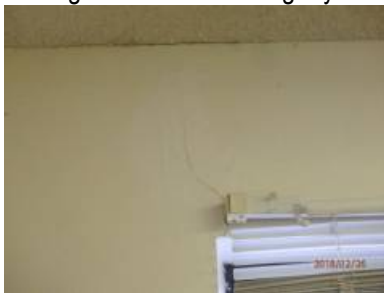
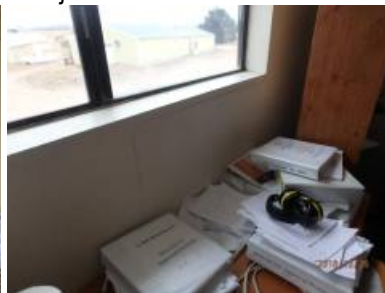
Wall Type, Drywall, Wall Condition - There is drywall damage present. These are usually cosmetic in nature. A drywall contractor should be consulted for repair(s) We recommend that anytime repairs are necessary, one should always get several bids before making a decision. Settling drywall seam joint cracks were observed = Cosmetic repair.[S/E Corner]

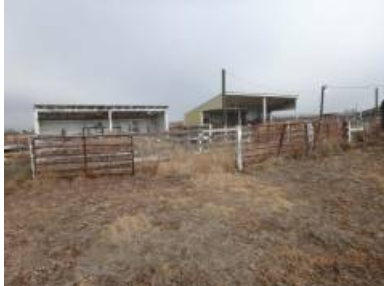
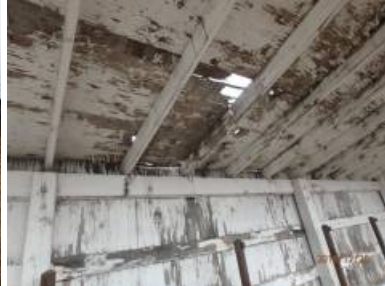
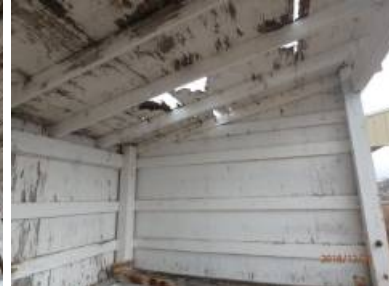
These building are in a condition that warrants their removal.

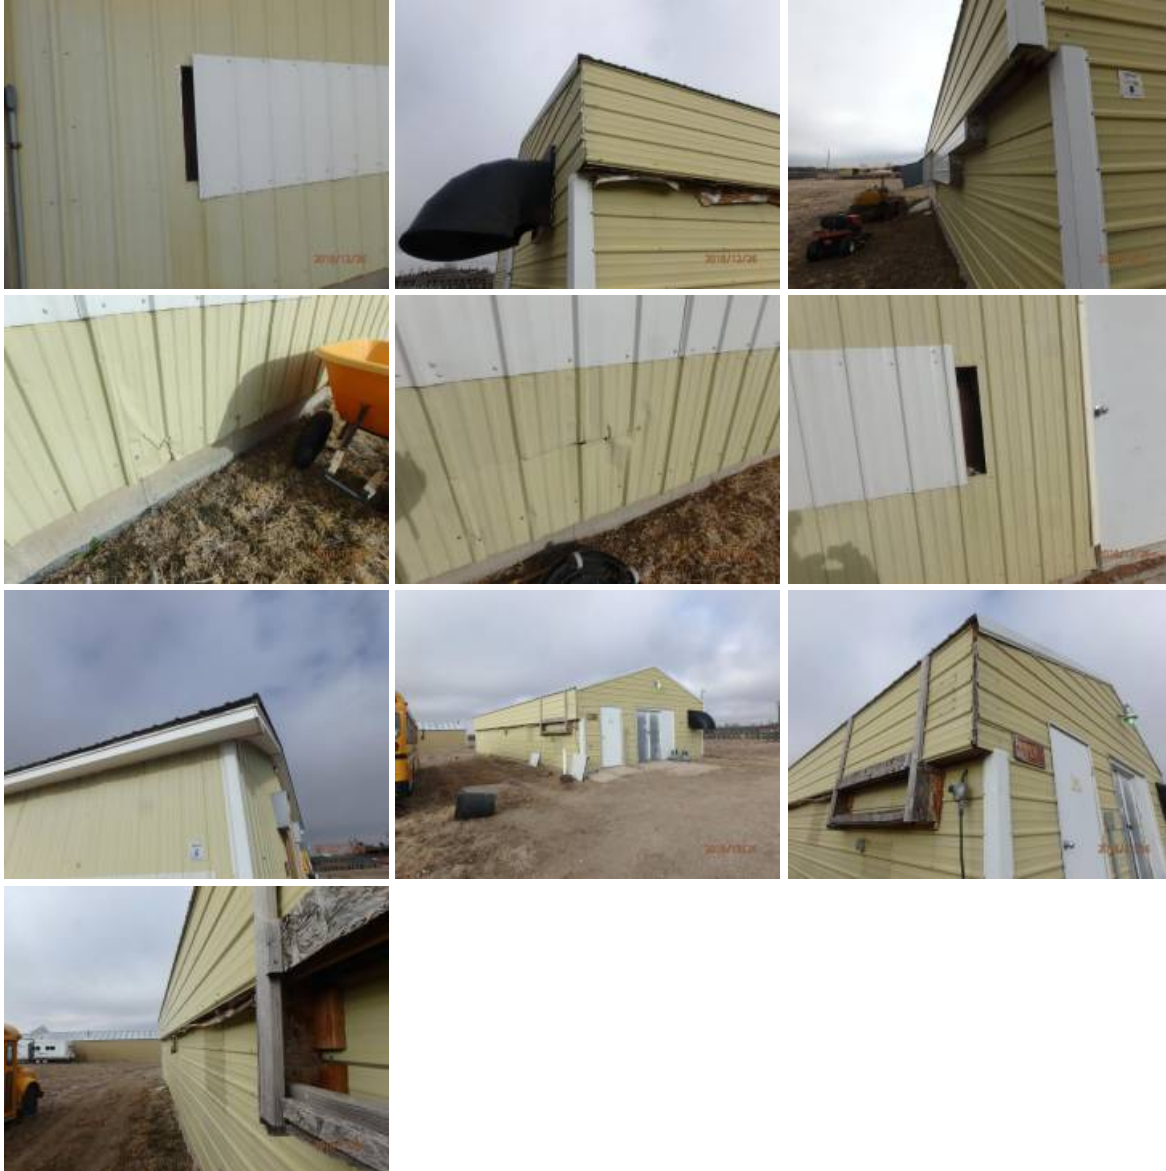
The building has damaged siding, loose and missing fascia.

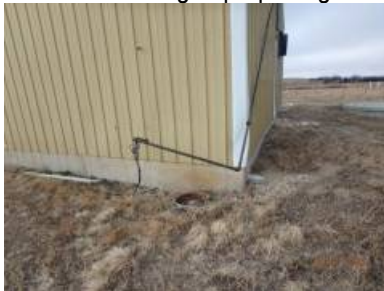
There is a damaged propane gas line that needs to be reconnected to the building.

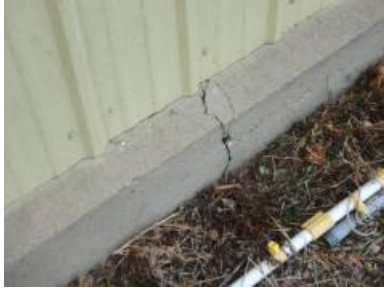
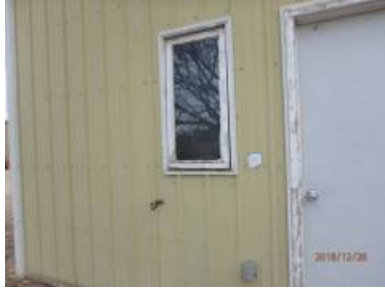
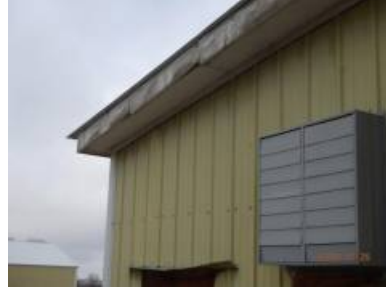
The exterior of this building is in disrepair. [damaged fascia, soffit, windows and trim, missing siding, cracked foundation.

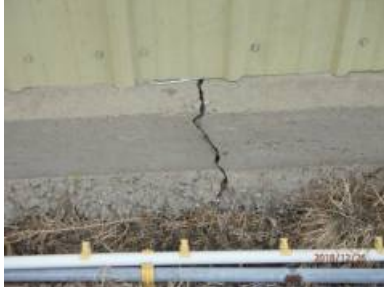
Cracks, Yes - Cracking was noted.

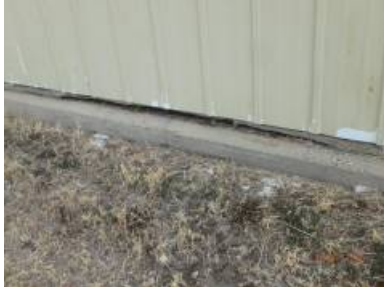
The 4x4 skids under the building are rotten and need replaced.
