# Case Study: Split Rock Lighthouse

Non-abrasive cleaning process helps state landmark shine

Restoring Split Rock Lighthouse

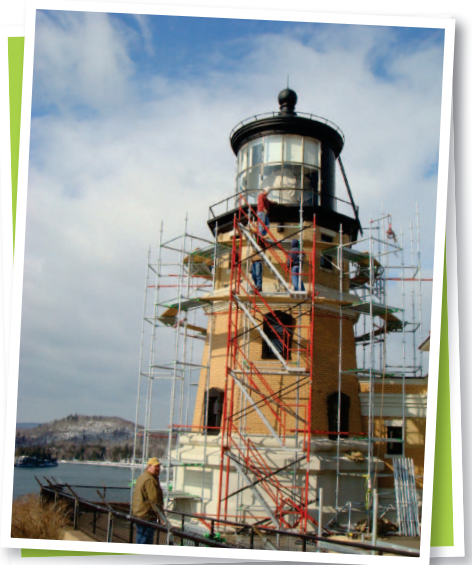
#### PHOTO

*Cold Jet dry ice blast cleaning being used to remove old paint and titanium putty from the cast iron dome of the Split Rock Lighthouse.*

During the first part of April 2008, Veit used Cold Jet's dry ice blast cleaning systems to remove the paint from the cast iron parts. Dry ice blast cleaning accelerates recycled CO<sub>2</sub> in the form of solid dry ice particles through a hose and high-velocity nozzle to remove old paint from the surface of the lighthouse. The combination of the kinetic and thermal gradient effects of dry ice blasting breaks the bond between the surface and the residue, which is blasted away and easily removed. The dry ice particles sublime upon impact, leaving no other cleaning by-product, and eliminating the added cost and inconvenience of

The Veit crew also cleaned out the pits in the cast iron dome, which had been filled with titanium putty. The putty is the preferred option

for filling the pits because it is able to withstand the rough elements that the lighthouse is constantly exposed to. The putty reacts the same as cast iron in that it will expand when heated and contract when cold. MHS was concerned with the areas that were allowing water to leak through or where there was standing water. With the old putty completely removed by the blasting process, MHS was able to put fresh putty in the pits and prevent the leaks.

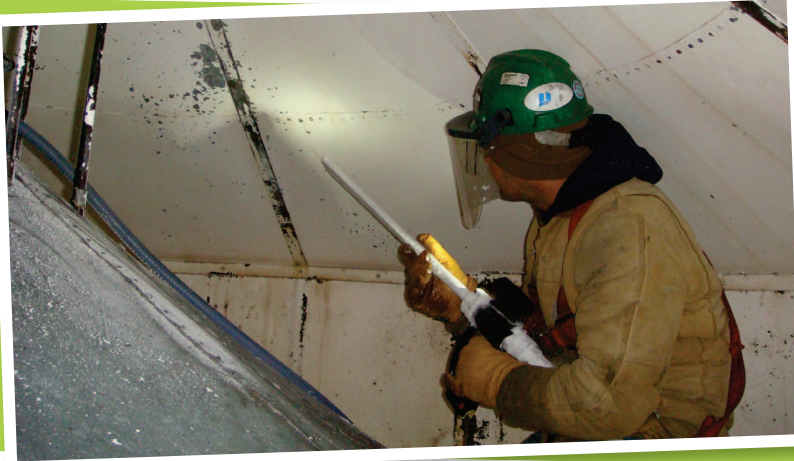
#### PHOTO

*Cold Jet's non abrasive cleaning process allowed crews to clean the interior of the lantern room.*

Because dry ice blast cleaning is a non-abrasive and non-conductive cleaning method, Veit also used the systems to clean the interior and exterior of the lighthouse's lantern room. The Split Rock maintenance crew was able to control the pressure of the blast stream, which ensured that no additional damage was done to the landmark. Veit was able
