## Hot-Dip Galvanized Steel

# Sales Bulletin

## Hot Dip Galvanized Vs. Painted Steel

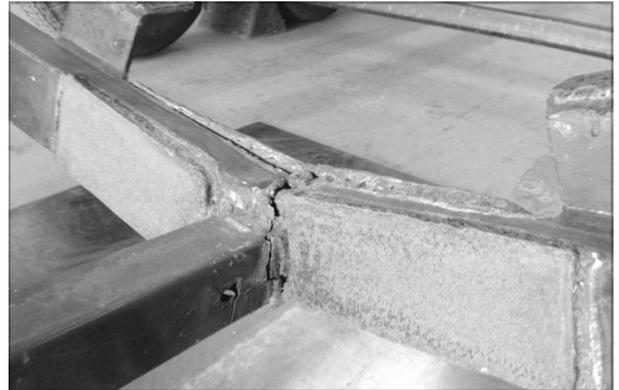
Failed rusty painted trailer frame.

The most serious drawback of paint systems is that if the coating is damaged and bare steel is exposed it will immediately begin to corrode. As the rust increases, it spreads under the remaining paint coating and separates it from the steel causing flaking and peeling. As the paint peels, more steel is exposed and the corrosion accelerates.

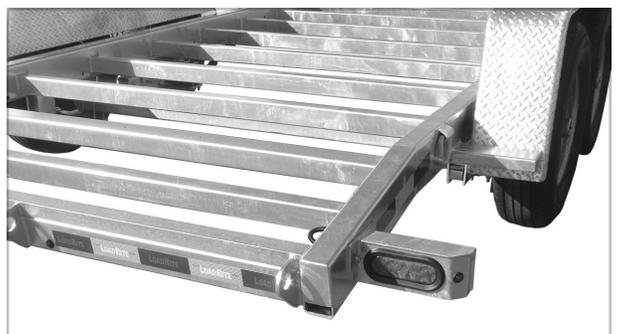
Typical galvanized trailer frame.
