*Client: Steve Davis*  
*Site Address: 6200 E COUNTY RD 56 Fort Collins*  
*Inspection Date: 01/13/2019*  
*Report # 1151*

## PROPERTY CONDITION REPORT

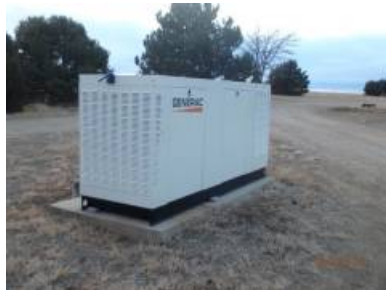
### **Special Utility Systems**

There is an emergency back-up generator for the subject property located at N/E Corner. These components and the switchgear were evaluated.

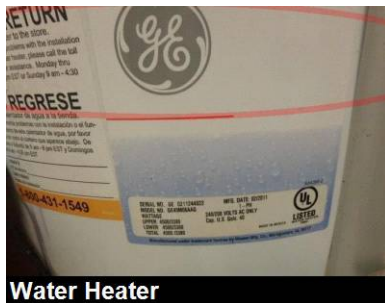
GE.

2011.

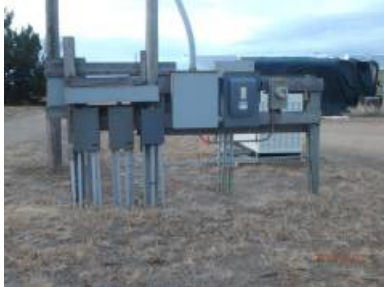
### Electrical Service

Underground System. Electrical service to the property is via an underground conduit from the utility company.

The conduit for the electrical service is damaged and may need to be repaired. [main building]

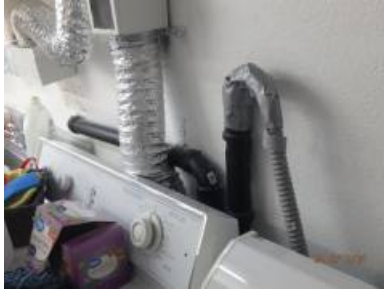
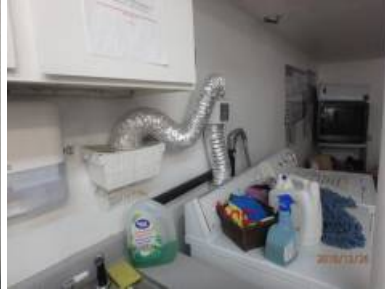
### Washer Hook-Ups:

Poorly plumbed.

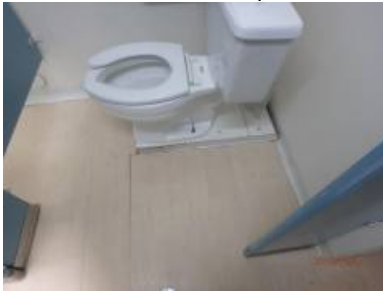
The toilet is on a raised platform.

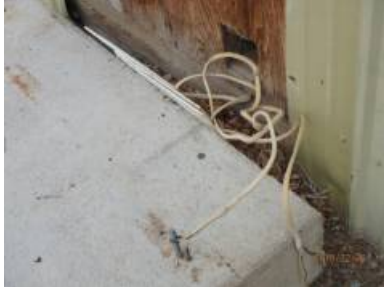
### Electric Service to Garage:

There is exposed wiring on the outside of the building.

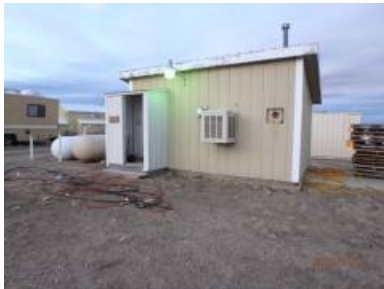
The fascia and soffit are in need of replacement.
